# Basic Troubleshooting Guide

Revised June 2009

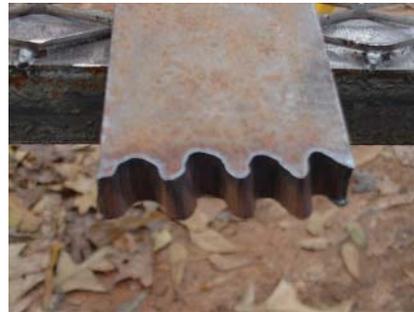
Bevel is caused by the motion of the plasma gas as it is emitted from the nozzle. In plasma cutting it is unavoidable. High definition plasma produces less bevel than a standard cutter.

Torch height, air pressure, quality of air, direction of cut, and consumable condition all contribute to how much bevel a cut has.

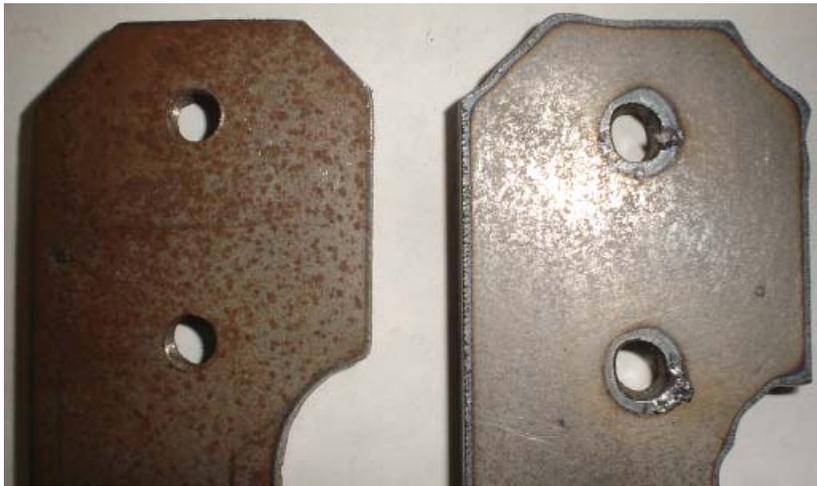
When a machine's performance suddenly changes or degrades gradually from one part to another this generally indicates something mechanical has changed. In cases like this check tightness of belts and set screws. Ensure that the gear to gear rack spacing is adjusted properly. The square of the gantry to the table can also cause parts to be out of shape.

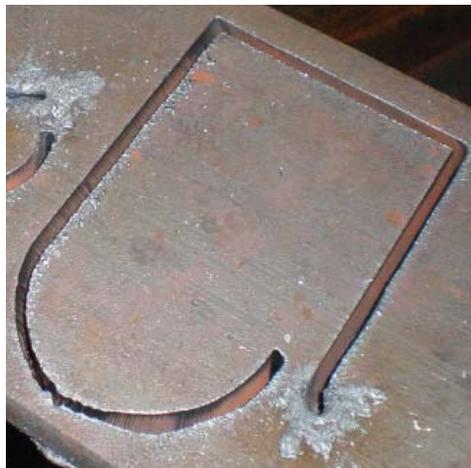
A cut where the path does not return to the start point indicates mechanical slipping or binding. In some cases it will be clear which axis is losing position. Examine the particular axis for loose set screws, loose belts, or physical obstructions.

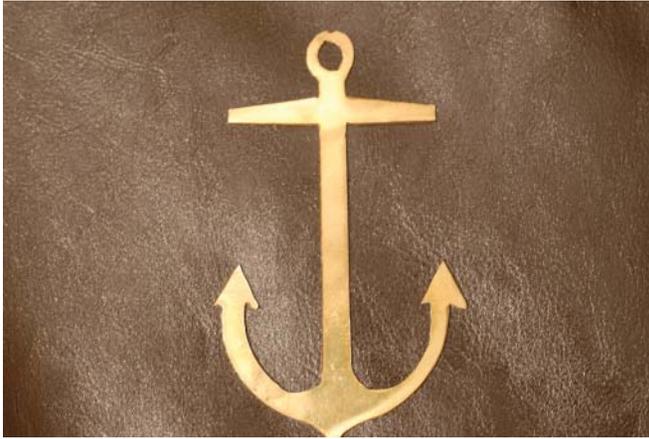
In some cases the slipping in one direction will be offset by slipping in the opposite direction of travel. This allows the part to be cut out but the tool path was not followed correctly. Set screws, belts, gear spacing, and square of the table should be checked.

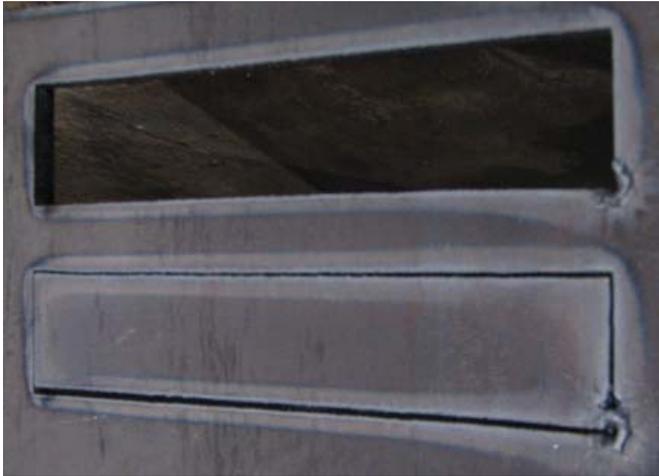
When the machine begins to move before a pierce is completed the cut will not complete. In this case the dwell time or pierce delay must be adjusted to allow for enough time to pierce the material.

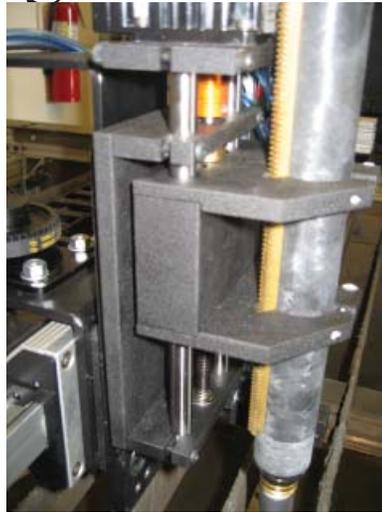
An automatic voltage height control relies on a connection to the plasma cutter to receive a raw arc voltage signal. This is used to maintain the height of the torch from the work piece. While cutting if the height climbs away from the material the “set voltage” is too high. Likewise if the torch tends to dive into the material the “set voltage” is too low.

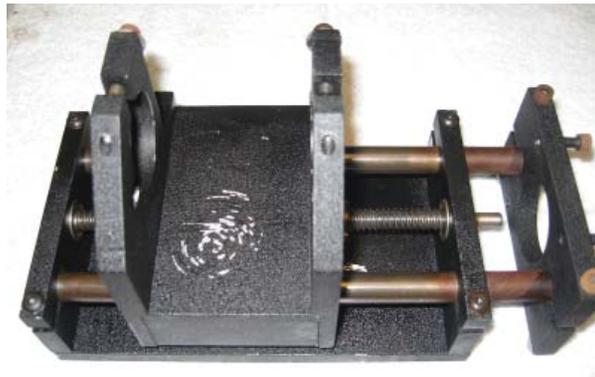
Most issues with the height control happen when it comes down to sense where the material is. During this operation the motor is looking for a small amount of resistance. If the height control does not come down all the way to the material before trying to fire this indicates that enough resistance was sensed during travel.

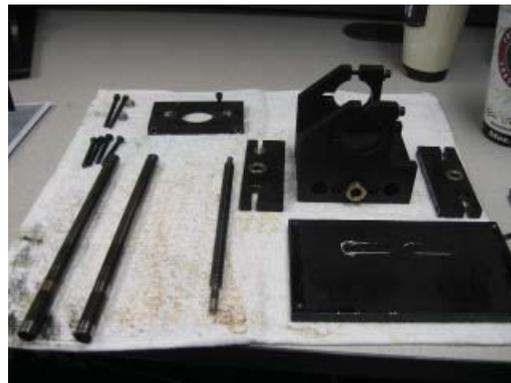
The cause of this resistance can range from a small piece of slag getting caught in the acme screw to a severe lack of preventative cleaning that necessitates a full break down and clean up. The first step to try would be to wipe down the screw and rods to ensure that no small obstructions are present. If this step does not remedy the problem a full cleaning is necessary.

When reassembling or adjusting the lifter station it is also critical to ensure that the two guide rails are parallel. If they are not this can also cause binding and behavior similar to a dirty lifter station.
